ANNUAL REPORT FOR 2007

Marks Creek Mitigation Site
Wake County
TIP No. R-2547 WM

Prepared By:
Natural Environment Unit & Roadside Environmental Unit
North Carolina Department of Transportation
December 2007

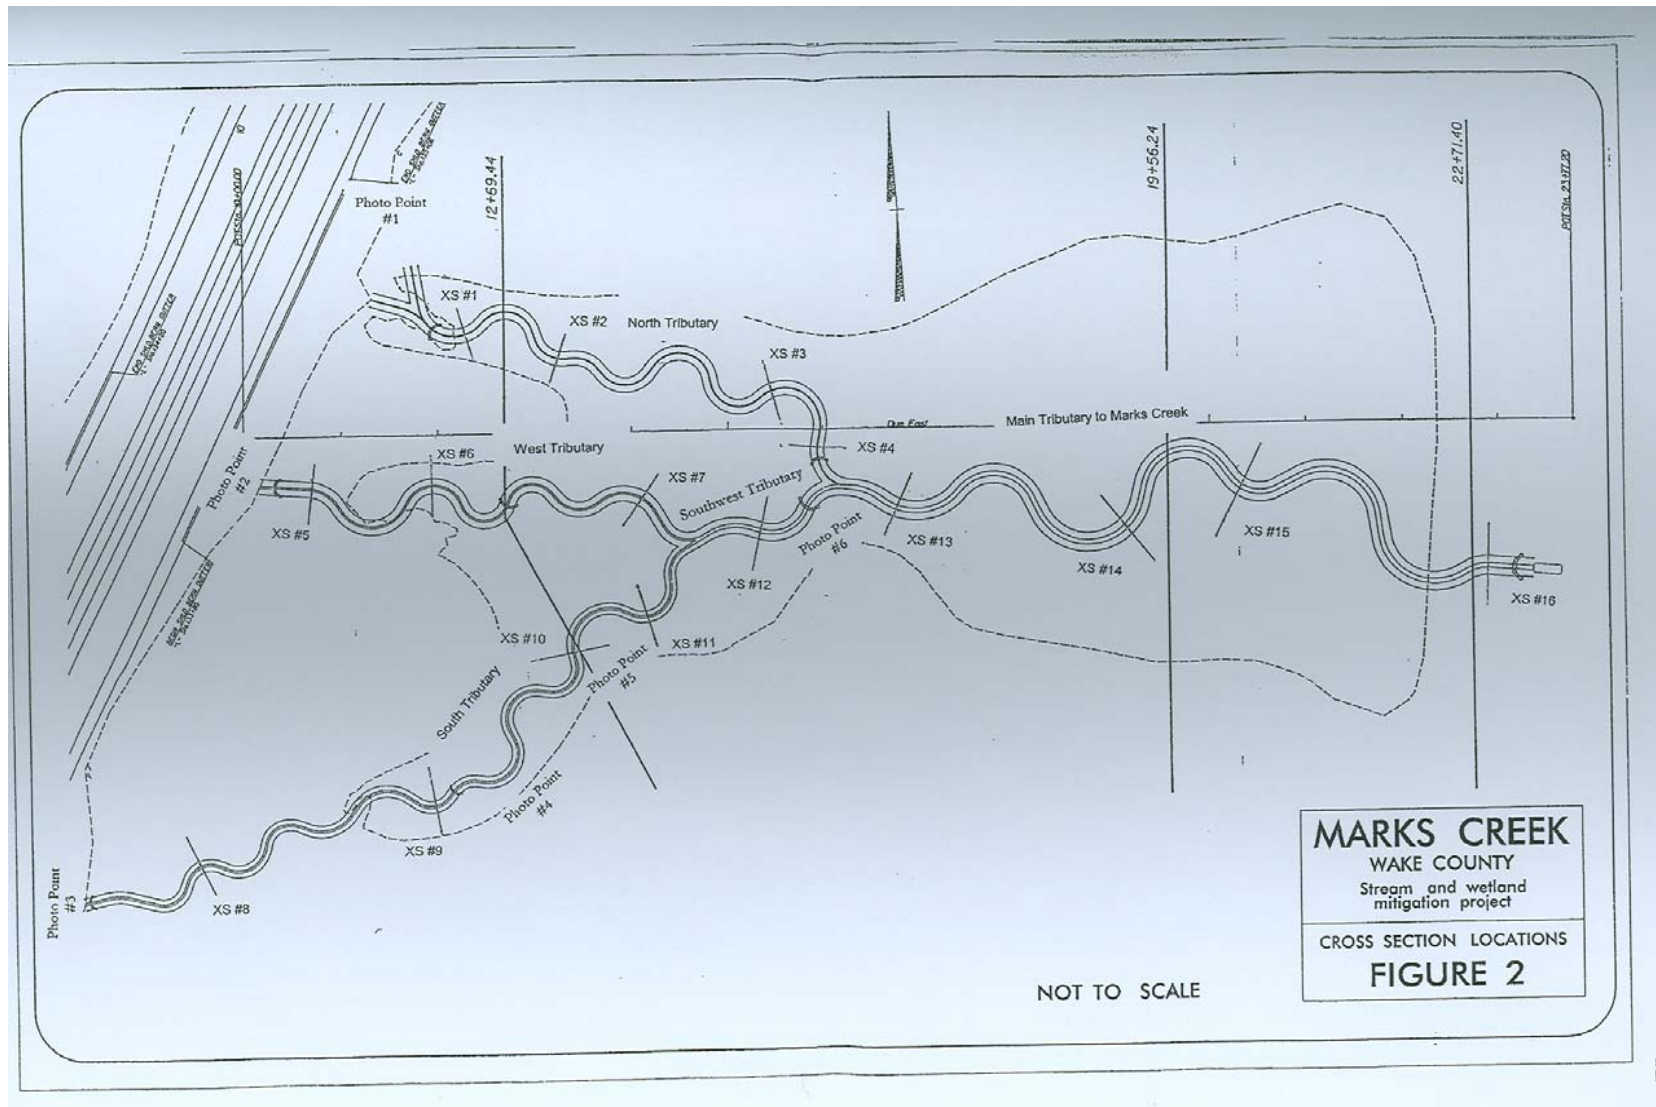
Figure 2. Cross Section Locations

The sixteen cross sections were established during the 2004 monitoring survey are being monitored on a yearly basis to determine the actual extent of aggradation or degradation. All of the cross section locations appeared stable when compared to the previous years monitoring data. Morphological comparisons are presented in the charts depicted below. Appendix A depicts each cross section comparison as well as a summarized table of morphological variables.

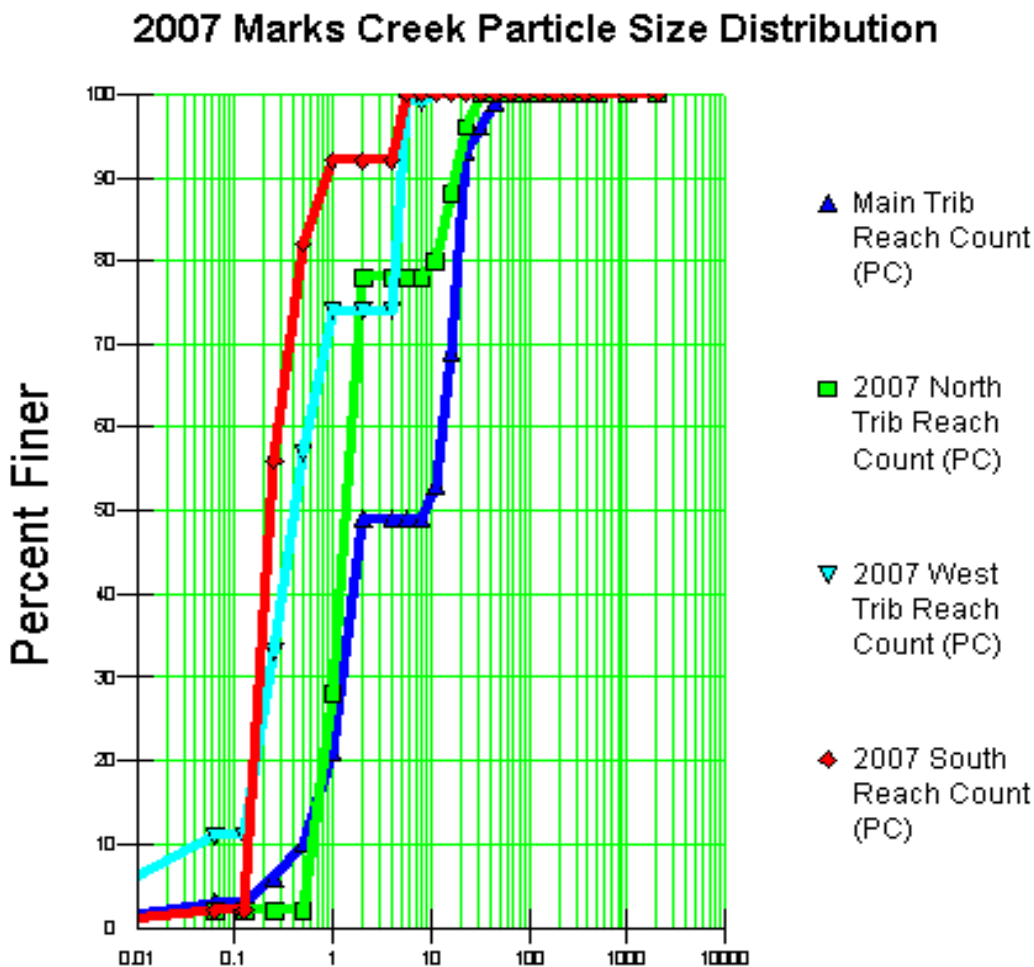
Chart 1. Particle Size Distribution

Pebble counts were taken along each tributary as a means to determine the extent of change in bed material during the monitoring period. The pebble counts taken during the Year 2007 monitoring period classified the stream as a gravel/sand bed system.

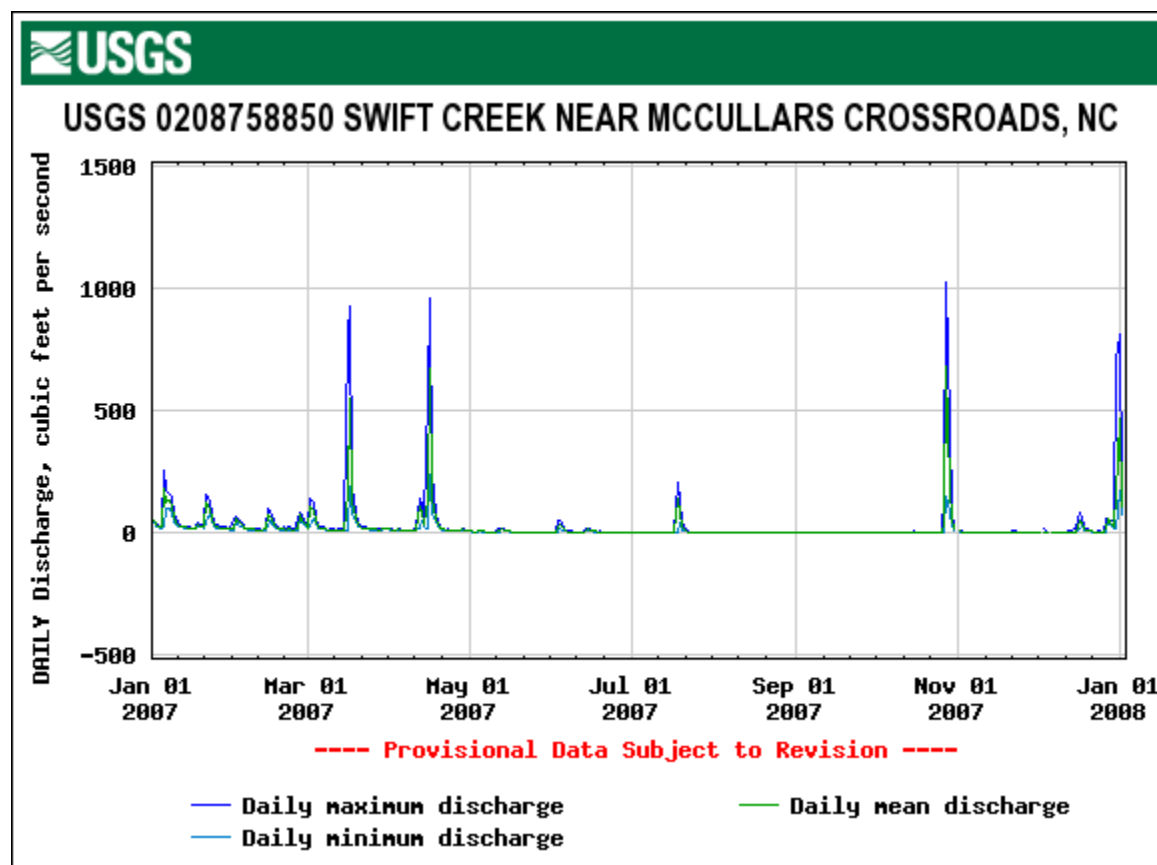
Monitoring requirements state that at least two bankfull events must be documented through the five-year monitoring period. No surface water gages exist along Marks Creek or its tributaries. A review of known USGS surface water gages identified one rural stream gage station within fifteen miles of the mitigation site. This gage station is identified as Swift Creek near McCullars Crossroads. The Swift Creek gage station has a drainage area of 35.8 square miles and is located approximately 15 miles southeast of the mitigation site near the confluence of Swift Creek and Lake Wheeler. The Swift Creek gage accurately reflects the hydrology and precipitation in the project area. It is situated in the USGS Hydrologic Unit 03020201. Datum of the gage is 251.46 feet above sea level NGVD29. Based on the drainage area associated with the gage, the correlated bankfull discharge according to the NC Rural Piedmont Regional Curves (USACE, 2003) is between 770 and 1,760 cubic feet per second (cfs). Following Year 2004 monitoring activities, a review of peak flows was conducted for the period between July 2002 and July 2004. According to USGS data, Marks Creek met its requirement of two bankfull events during the first year of monitoring, with both of the events happening in 2003. Reviews were also conducted for 2007. The USGS graph presented below indicates that one bankfull event occurred in 2007.

Based on information obtained from the USGS, the Marks Creek Site has met the required monitoring protocols for hydrology as it relates to bankfull events that have occurred on site since the time of construction.
